CONTRACTOR REPORT ARPAD-CR-82003

**DETECTION OF CRITICAL DEFECTS IN THE M712
COPPERHEAD CONTROL SECTION HOUSING**

**W. R. RANDLE
B. D. WOODY
MARTIN MARIETTA CORP.
ORLANDO AEROSPACE DIV.
ORLANDO, FL 32855**

OCTOBER 1982

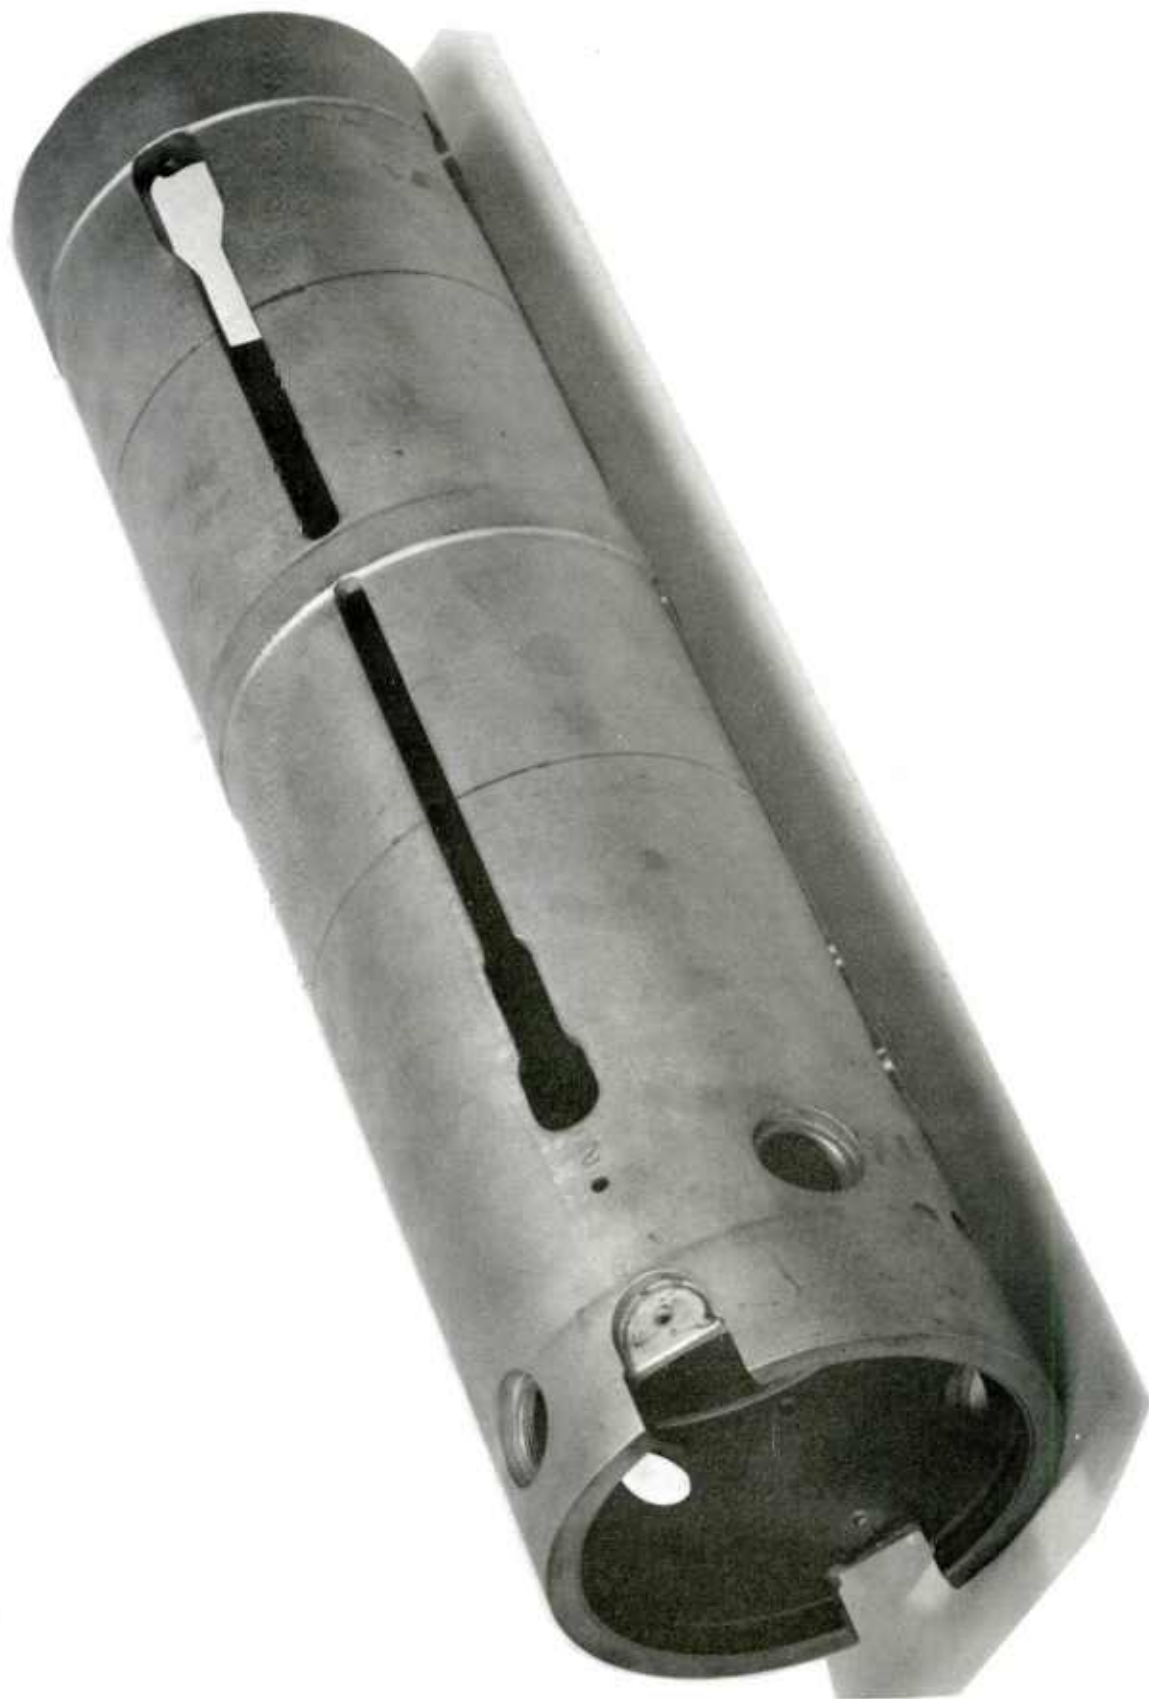
Figure 1. Copperhead control housing

This program was conducted to determine the inspectability of the Copperhead control housings (fig. 1) for critical surface flaws which might occur as a result of heat treatment. It is based on a crack inspection map and the associated crack size limits developed by a fracture analysis study (ref 1). The map (fig. 2) includes four types of crosshatching to delineate the zones in which certain sizes of cracks are allowable without impairment of the housing function. Within each zone the allowable size is further categorized as an edge, corner, or surface crack. The legend accompanying the maps provides specific values for all 12 acceptance limits (4 zones X 3 types). The geometry assumed for the three types is shown in figure 3. Any flaw larger than the limit for a particular zone or type would, theoretically, cause catastrophic failure of the control housing as the round was fired.

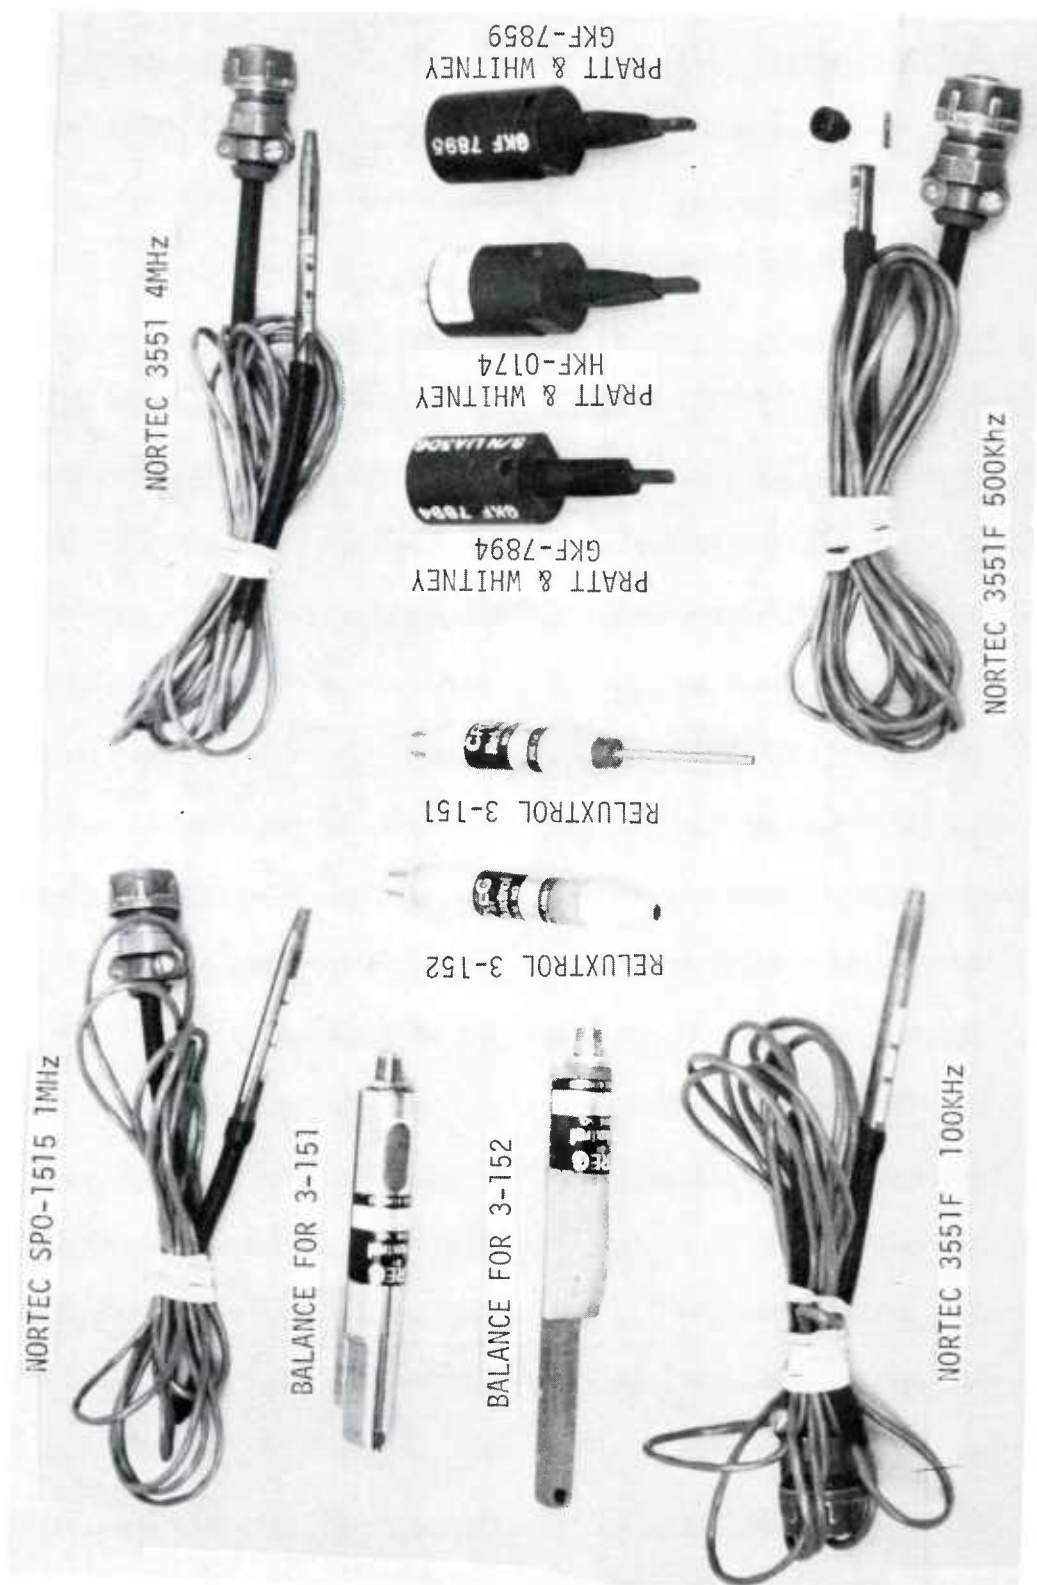
Figure 4. Eddy current probes

The probes used in this program are shown in figure 4. Because the Reluxtrol 3-151 and 3-152 probes do not have self-contained balancing coils, the other two Reluxtrol probes were used for balance purposes not subjected to evaluation.

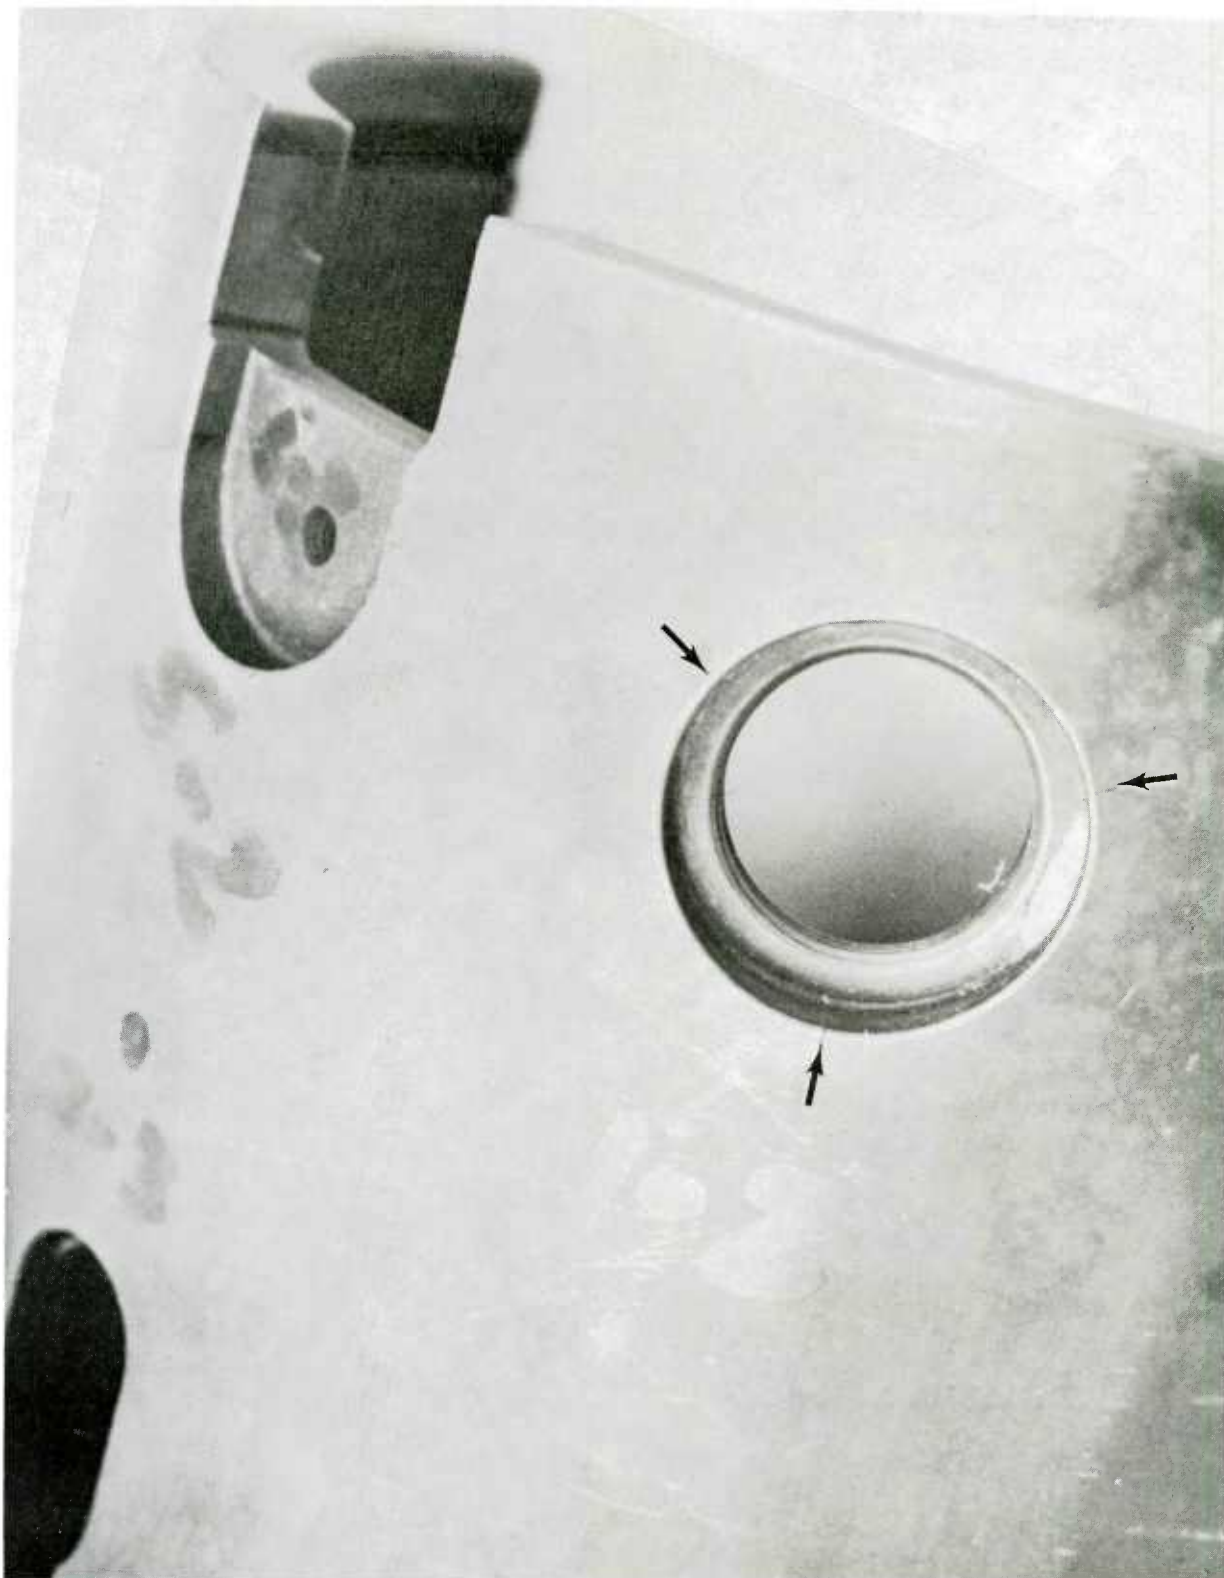
Figure 7. EDM slots in control housing

Because it is generally accepted in eddy current studies, the process of electric discharge machining (EDM) was selected to cut very narrow slots of known dimensions in a control housing to simulate cracks. The crack maps were analyzed and the dimensions and locations of slots were established so that all possible combinations of crack type (edge, corner, surface), crack size (from smaller than the smallest to larger than the largest allowable), and surrounding geometry (slot, hole, recess) for both ID and OD were included. Two control housings were required to accommodate all the slots. To facilitate EDM electrode access, the control housings were cut in half longitudinally as shown by figures 5 and 6. Although these particular housings were neither machined nor heat treated using precisely the same equipment or processes planned for production, they were sufficiently similar to production parts to serve the purposes of this investigation. Close-ups of some typical EDM slots are shown in figures 7 and 8.

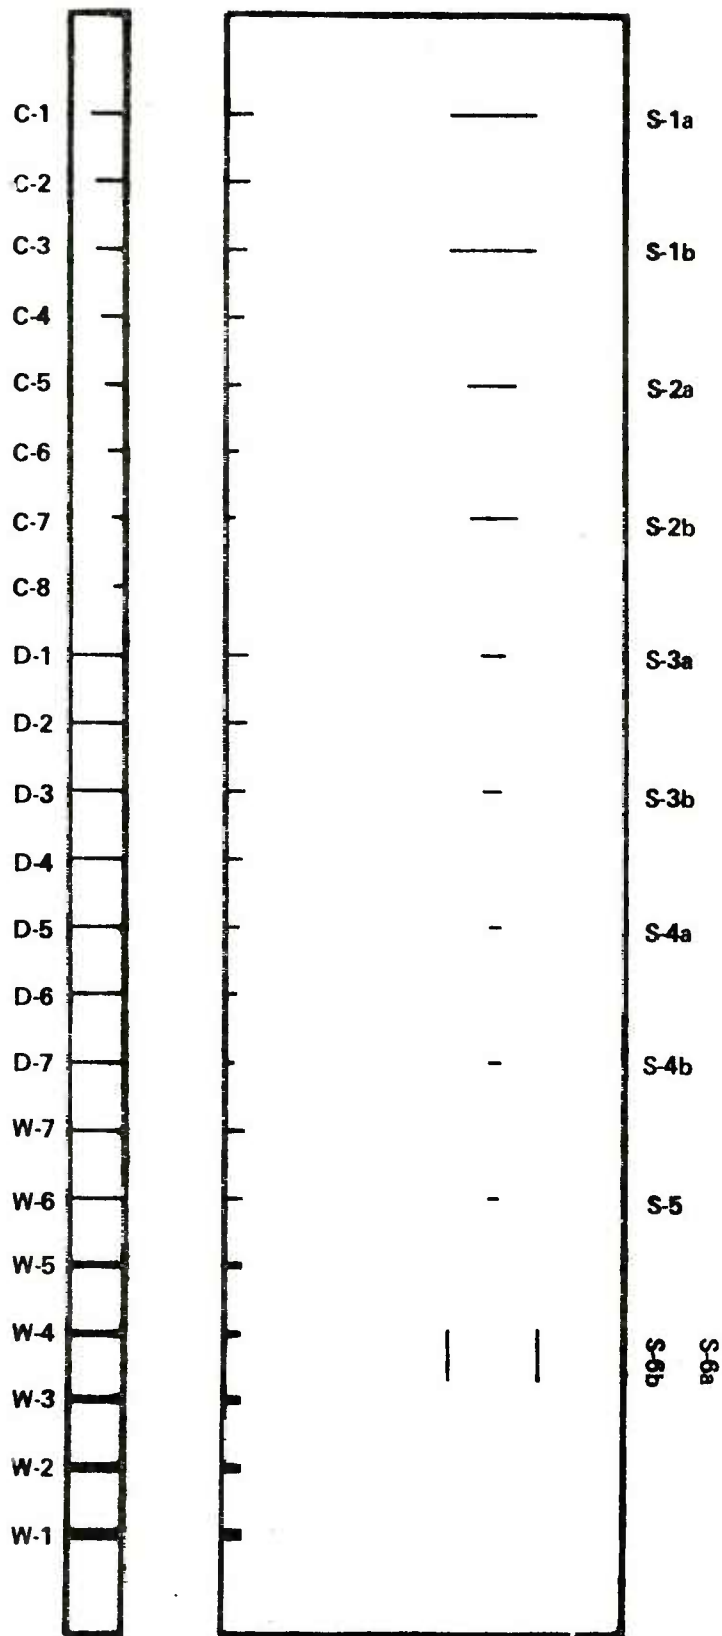
Figure 9. Ideal test specimen

MAKE FROM 4340 STEEL HEAT TREATED PER COPPERHEAD CONTROL HOUSING PROCESS
 GRIND TWO FACES FLAT AND PARALLEL WITHIN 0.0005 INCH
 GRIND TWO LONG EDGES FLAT AND PARALLEL WITHIN 0.0005 INCH
 EDGE-TO-FACE ANGLES 90 ± 0.1 DEG
 DO NOT BREAK SHARP CORNERS
 GRIND FINISH BETTER THAN 32 RMS
 MAINTAIN HEAT TREAT CONDITION THROUGH GRINDING

A geometrically ideal test specimen was fabricated from 3/8-inch thick 4340 steel plate that had been heat treated by the same process as the production control housings. Special attention was given to smoothly ground parallel surfaces and to sharply formed 90° corners. This ideal specimen allowed better accessibility for more precise EDM slotting, as well as more simplified test positioning and holding than the control housing parts. The specimen is shown in figure 9 and the dimensions of the slots listed in table 2. The finished edge slots are shown in figures 10, 11, and 12. The specimen contains additional constant depth and varying width slots not called for by the crack map. The effects of these slots proved to be interesting.

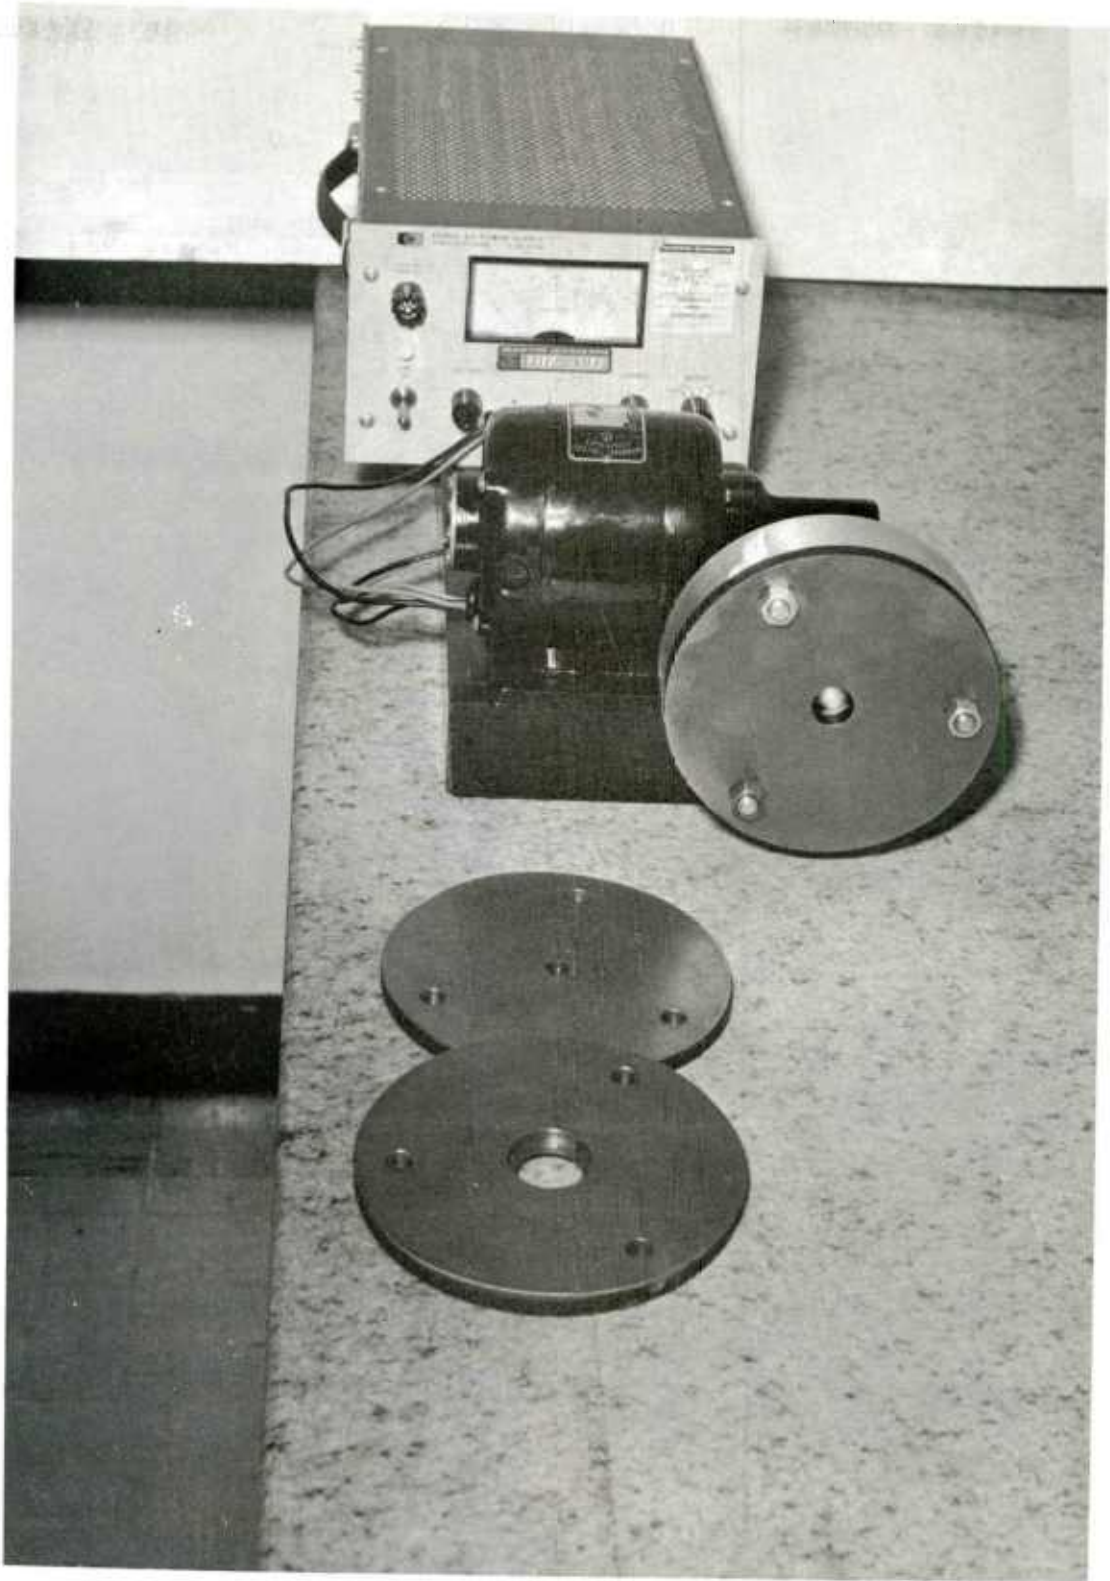
Figure 13. Hole test setup

To evaluate the many holes and recesses of the control housing without geometry induced noise, a special set of disc shaped ideal specimens were fabricated. The object was to minimize the difficulty and number of probes required to compensate for varying (but within tolerance) diameters. The technique would rotate the hole about an accurately and simply positionable probe rather than rotating a probe within the hole. One of the plates mounted on its matching mandrel and variable speed drive motor is shown in figure 13.

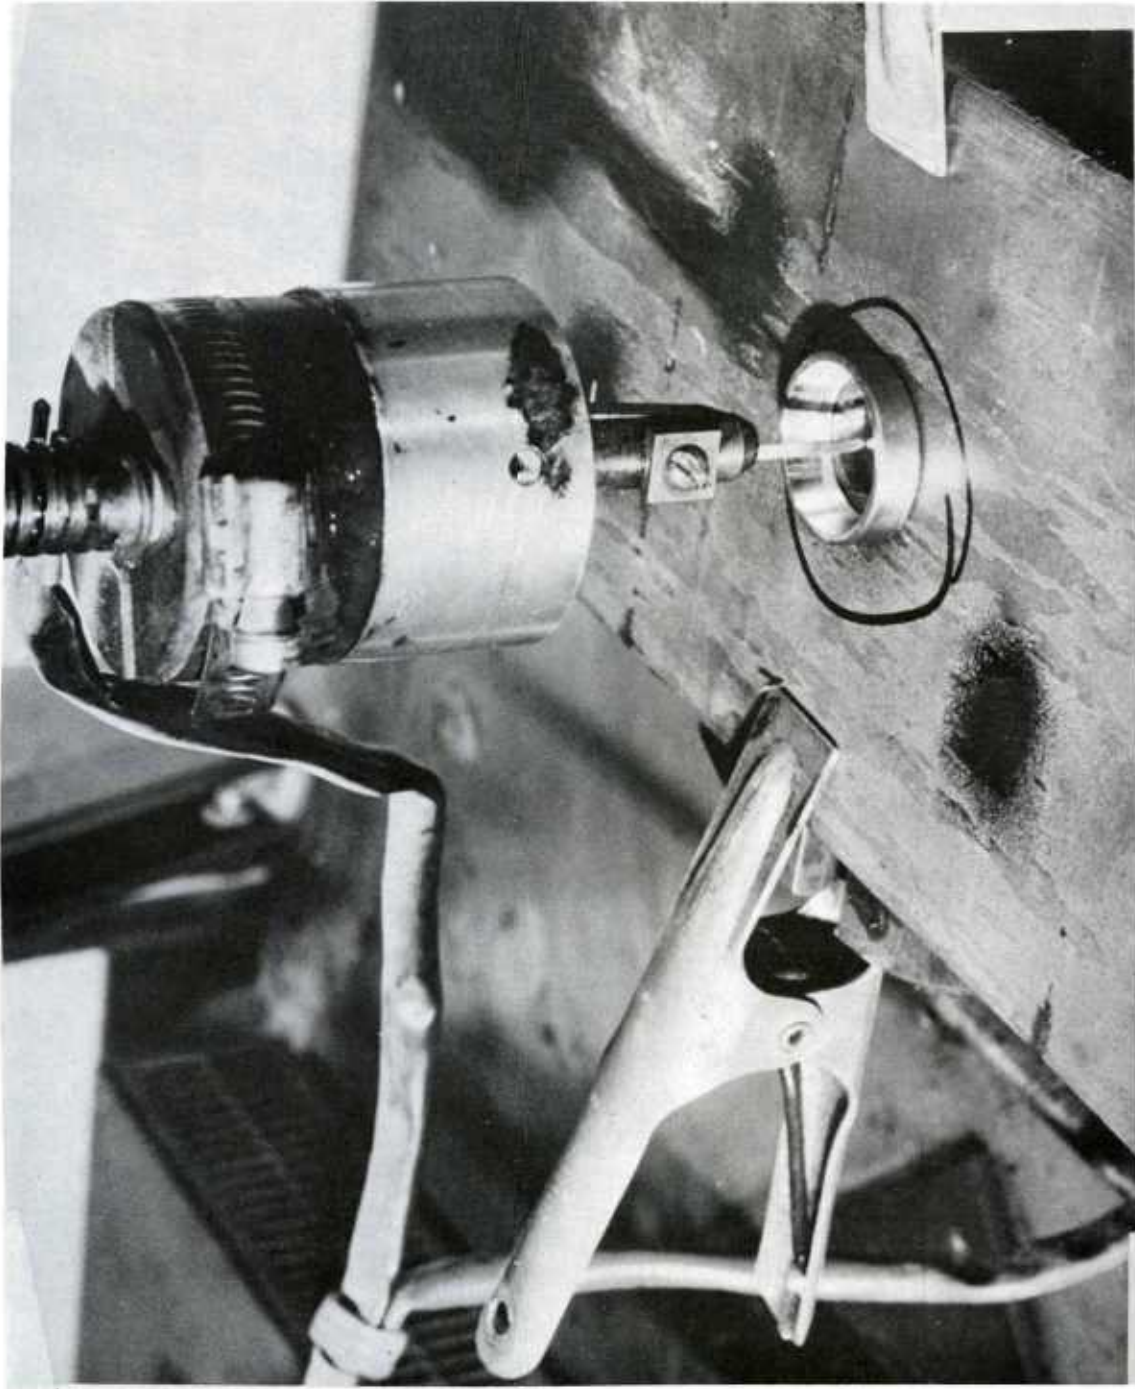
Figure 14. EDM generation of starter notch

EDM starter notches were introduced into the plate stock as shown in figure 14. The depth of the starter notch was monitored by a dial indicator and controlled by a mechanical stop on the electrode drive mechanism.

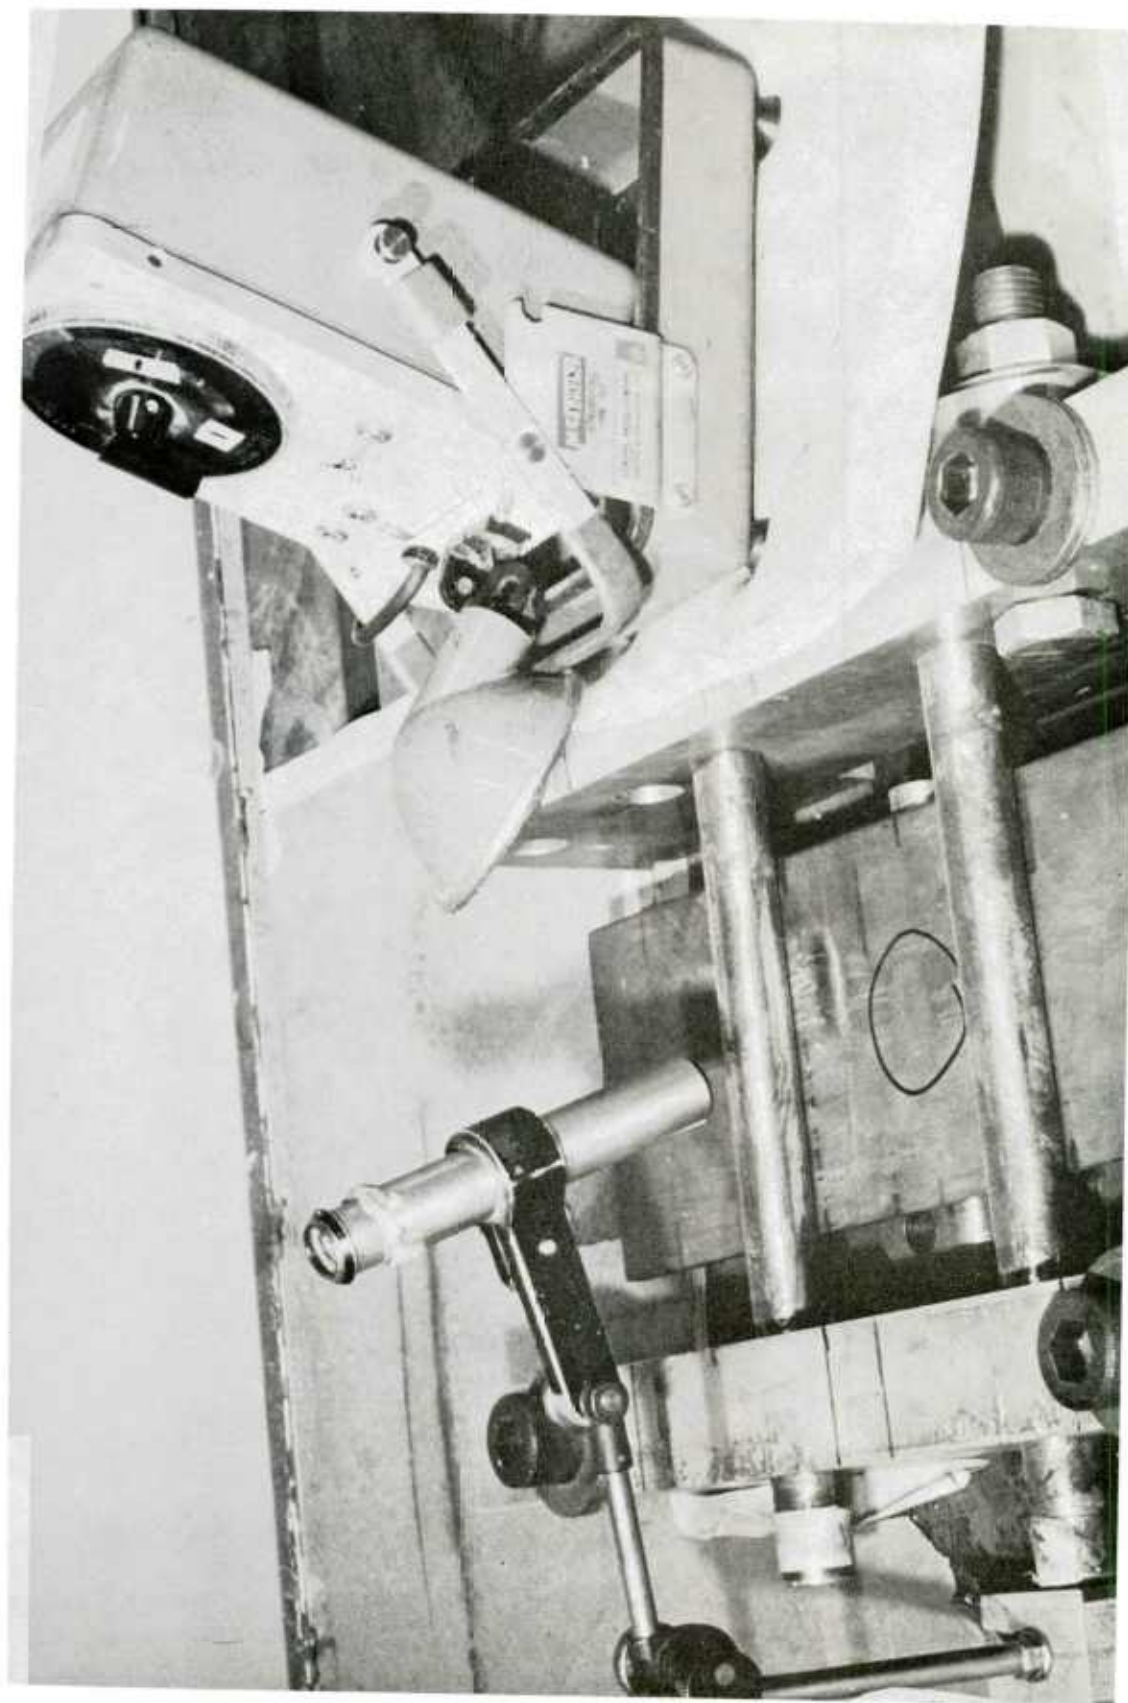
Figure 15. Fatigue crack growth setup

The cracks were initiated and grown in a rotating mass fatigue machine (bending fatigue) shown in figure 15. This machine has options for pre-loading the specimen for fatigue in the tension-tension mode or for loading in pure tension. Cracks were grown in tension-tension. Crack initiation and growth were monitored with a microscope and stroboscope lighting. Crack length was measured using a calibrated reticle in the eyepiece. After a crack was grown to the desired length, the panel was repositioned in the fatigue machine to grow cracks in other areas. A 10X magnification of a starter notch and its fatigue crack is shown in figure 16. The required EDM electrode shape, size, depth, pre-load, and fatigue load were determined by fracture and examination of trial cracks. Once these parameters were established, consistency of crack growth was assured by monitoring length during growth.

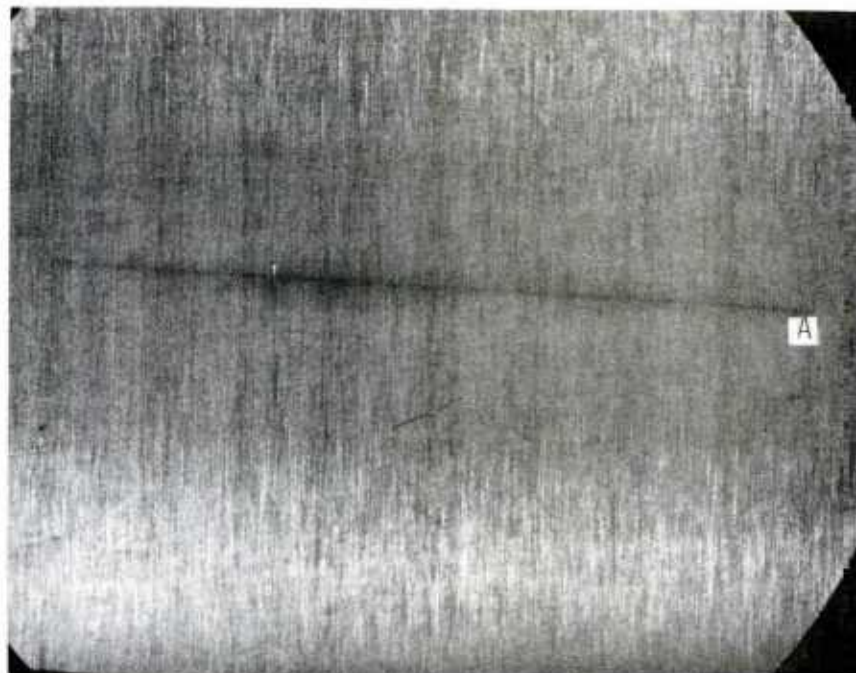
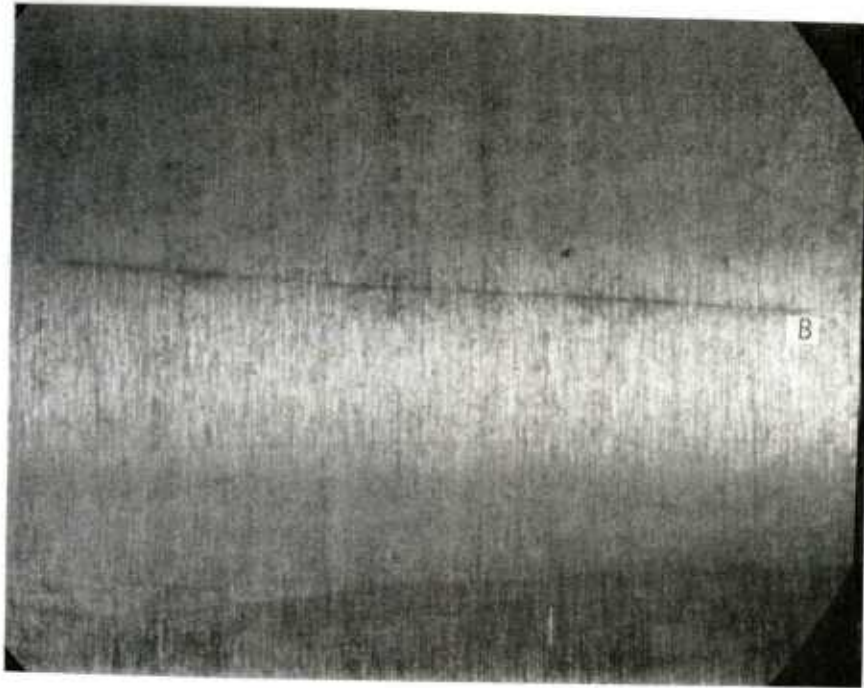
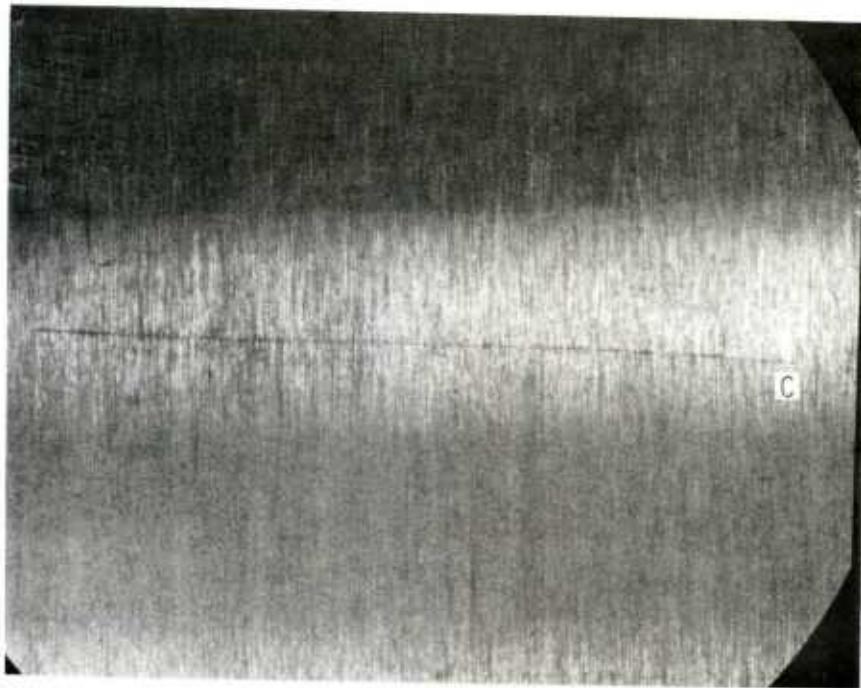
Three straight, transverse cracks approximately 0.400-inch long were grown in a plate. It was estimated that the process produced cracks 0.200-inch deep. The plate was cut into three pieces, each containing a centered crack. The pieces were ground on the back side to produce a flat surface, then on the front side to produce a flat surface and to remove the starter notch. The result was three small plates with flat, parallel faces, each containing a natural crack approximately 0.400-inch long. Photomicrographs of the cracks, designated A, B, and C are shown in figures 17, 18, and 19.

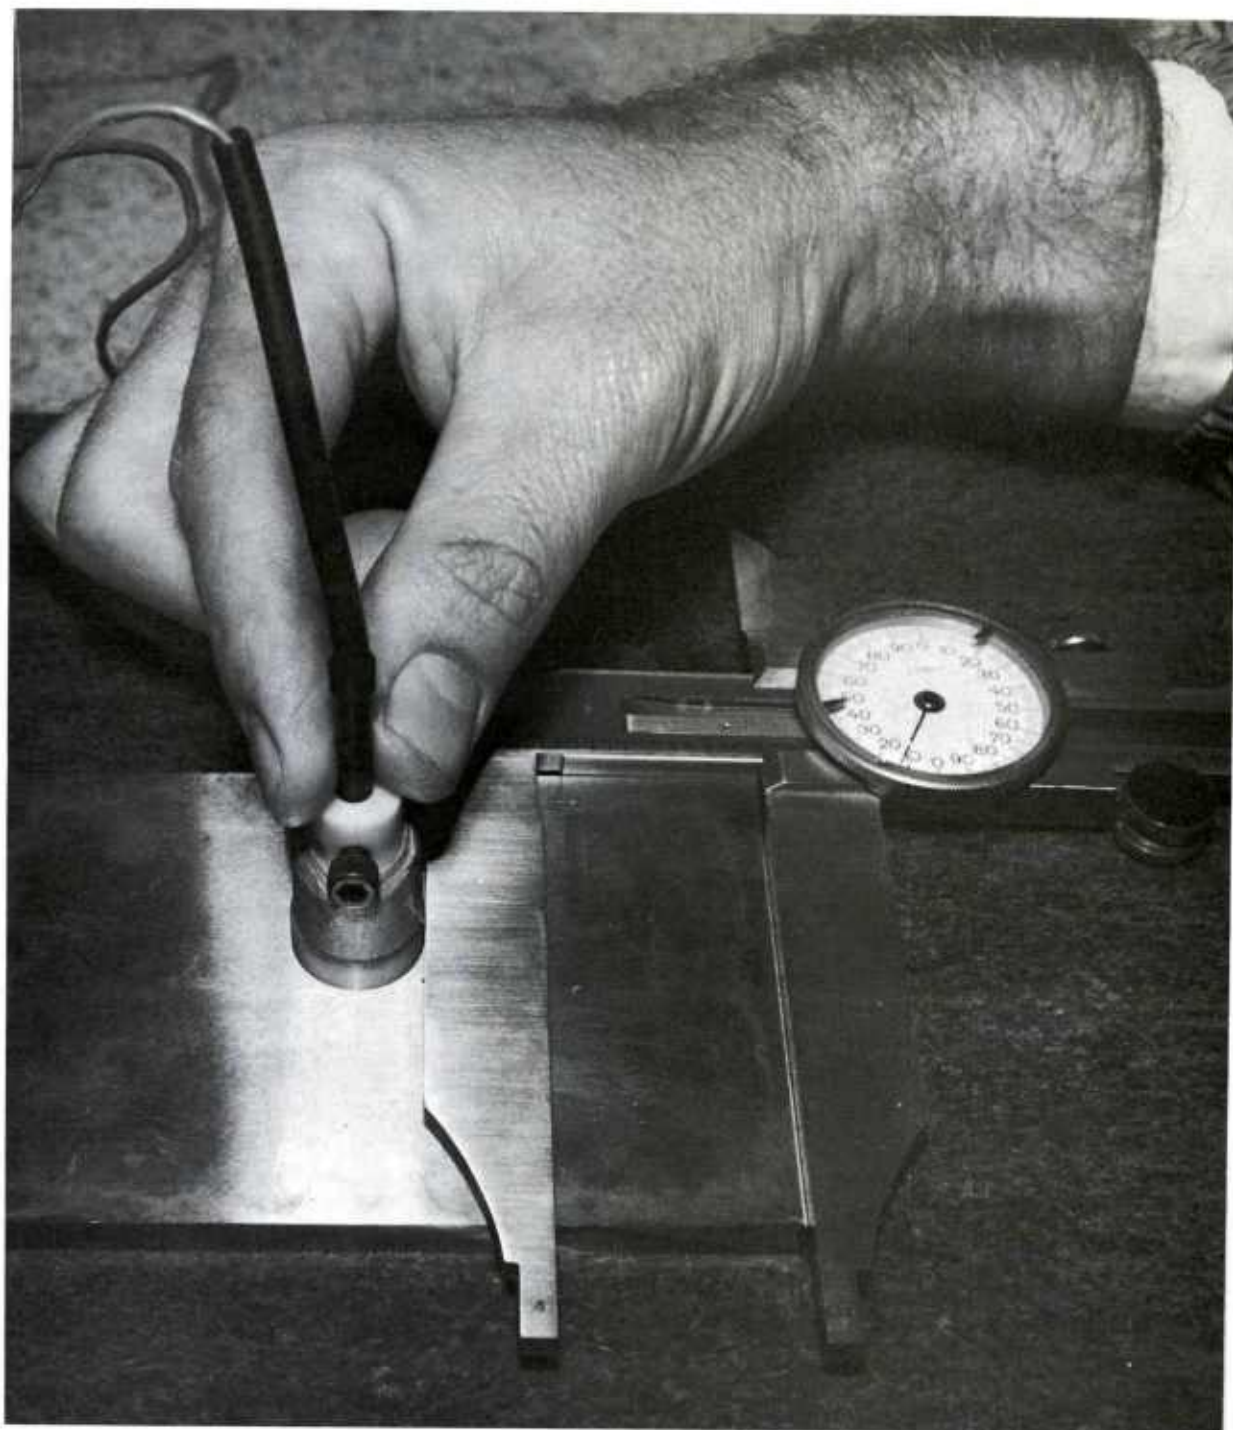
Figure 34. Manual scanning of fatigue cracks

The arrangement used for manual scanning is shown in figure 34. The probe is mounted in a nylon shoe that holds it vertical, maintains a constant 0.006-inch liftoff, provides a rotational reference in the form of the set screw, and provides a surface to be held against the vernier caliper. The vernier caliper provides accurate repeatability of the probe paths over the crack that is set 0.050-inch larger for each successive pass.

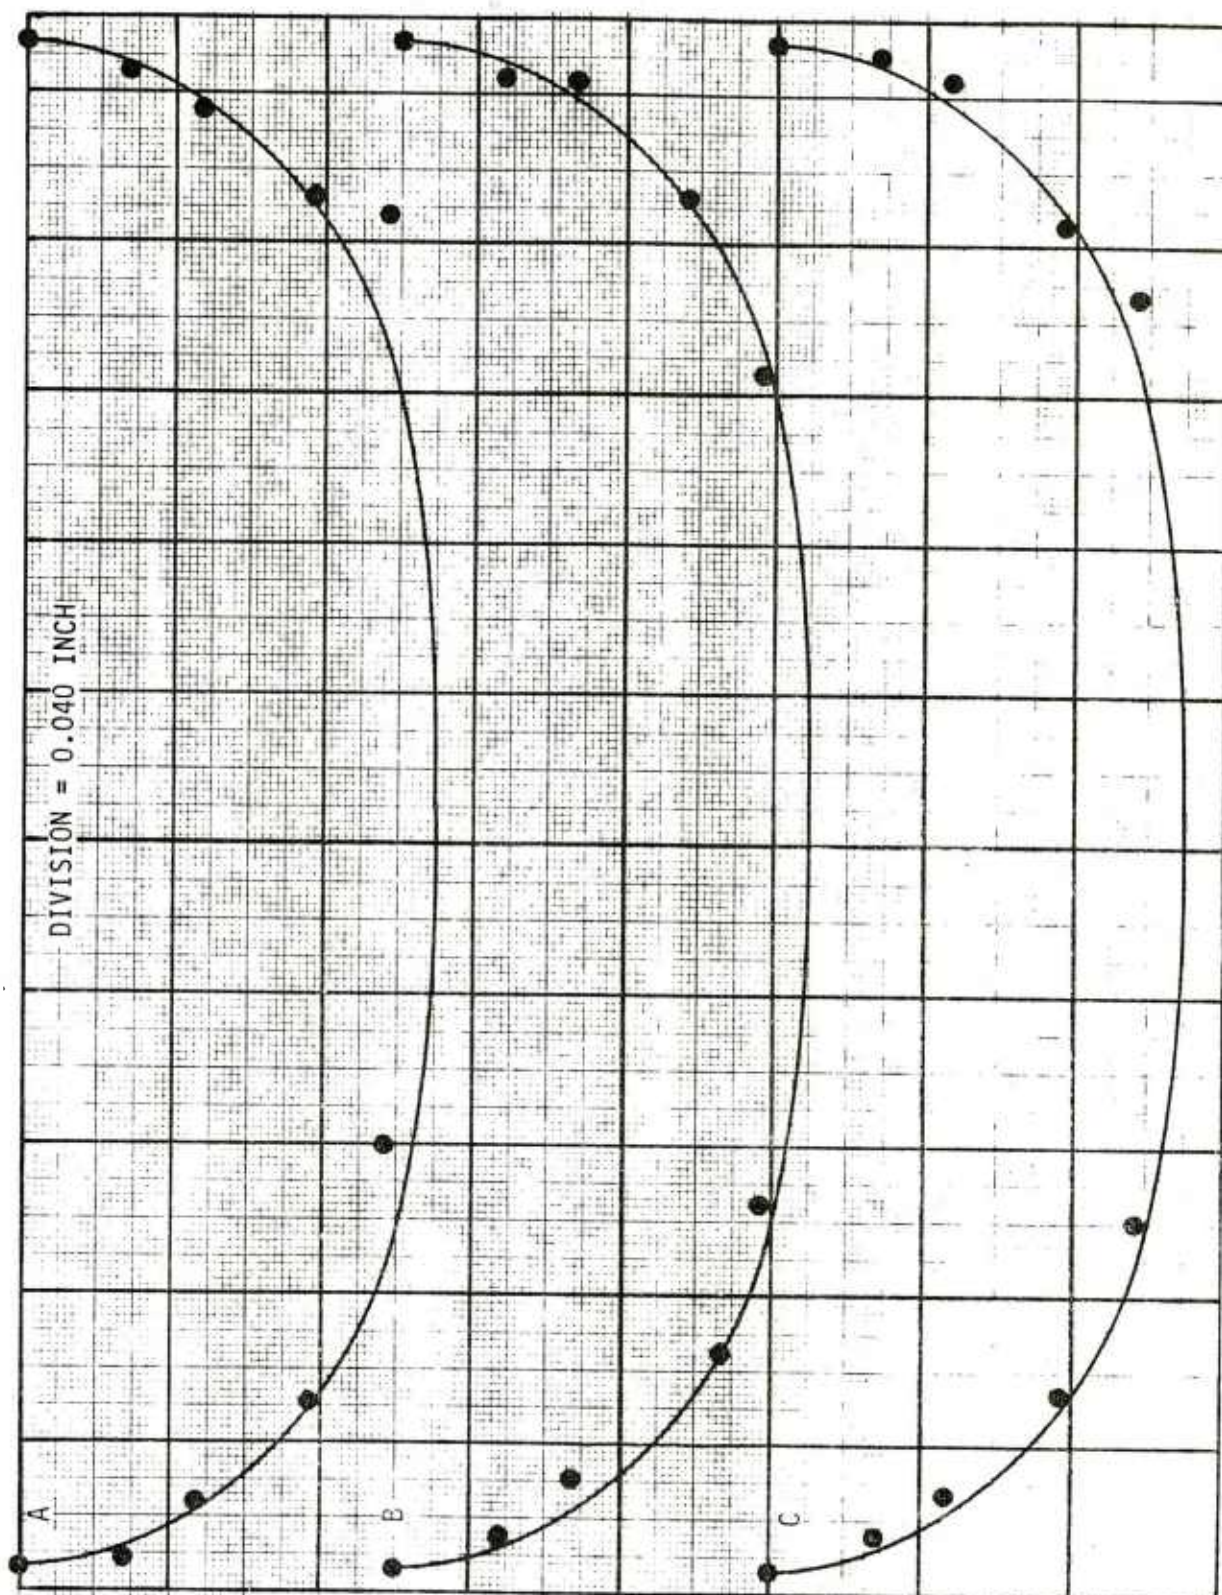
Figure 35. Dimensional profiles of A, B, and C

The dimensional data gathered during the successive grindings is plotted on figure 35. The scale factor is linear and is the same in both X and Y axes so that the aspect ratio of the cracks is presented directly. The three curves used to join the data points are identical. They prove the controllable nature of the crack growth process and of the profiling technique.
